Garden of the Gods Restoration Report

Current Conditions and Recommendations

Prepared for
Parks & Recreation Department
City of Colorado Springs, Colorado

Rocky Mountain Field Institute
Bruce Byers, Jim Ebersole, & Mark Hesse, Consultants

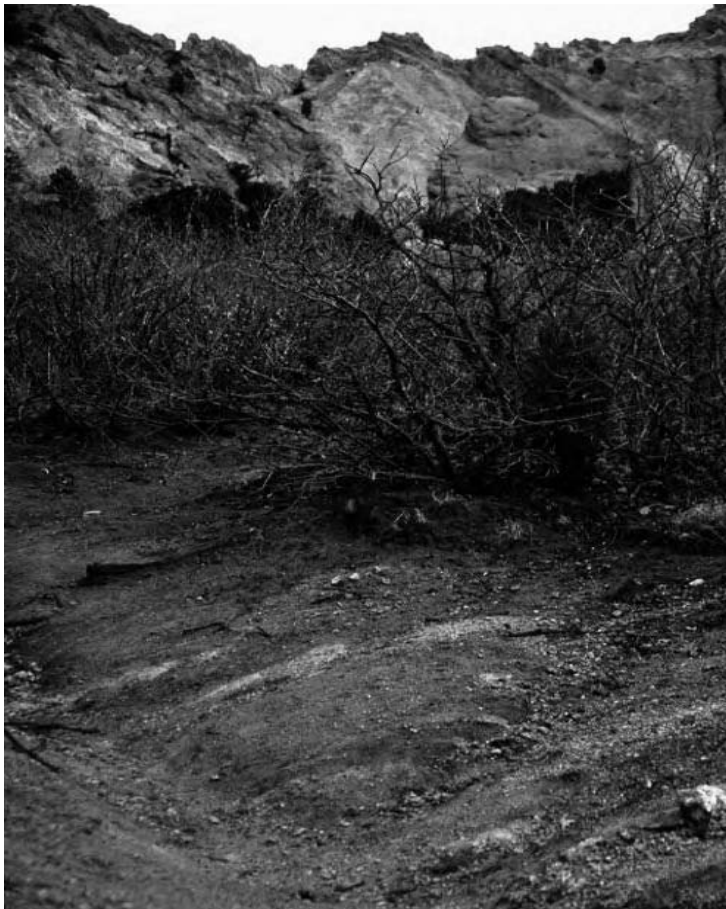
This photo shows major vegetation and soil loss initiated by Park visitors walking off of designated trails. This site was level and vegetated with native scrubs and grasses. Trampling killed the plants and initiated soil erosion. This is typical of many areas in the Park.

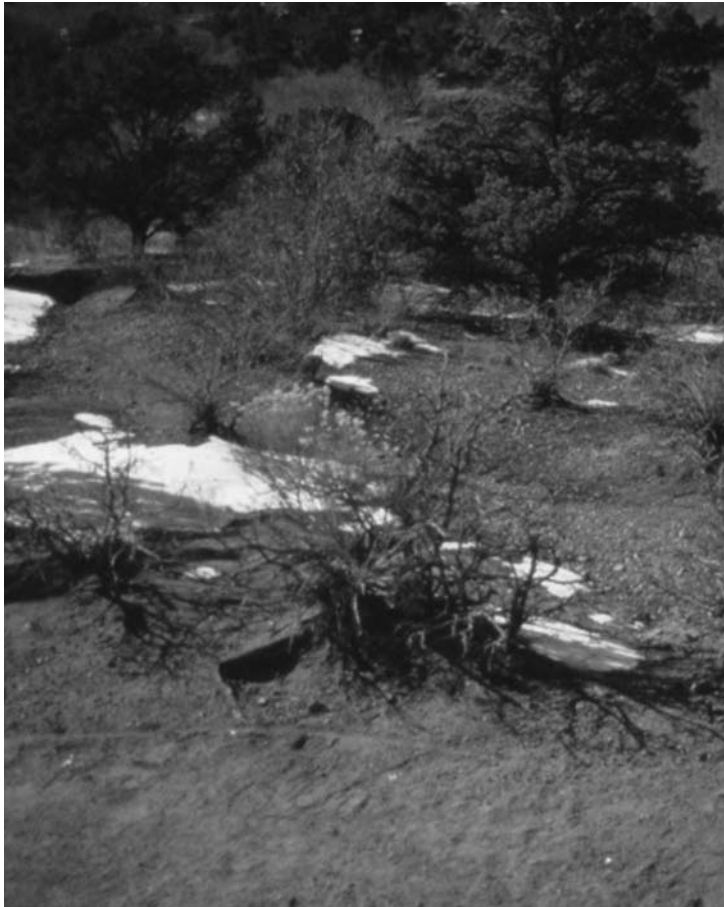
Extensive vegetation and soil loss between scrub oak and mountain mahogany shrubs above the upper Scotsman Trail are typical of many sites in heavily used areas of the Park. A loss of one foot or more of soil has resulted in “pedestals” of vegetation. Erosion is the result of a number of interacting causes: loss of vegetation from off-trail trampling and social trails, drainage from designated trails, and inadequately managed runoff from Juniper Way Loop road.

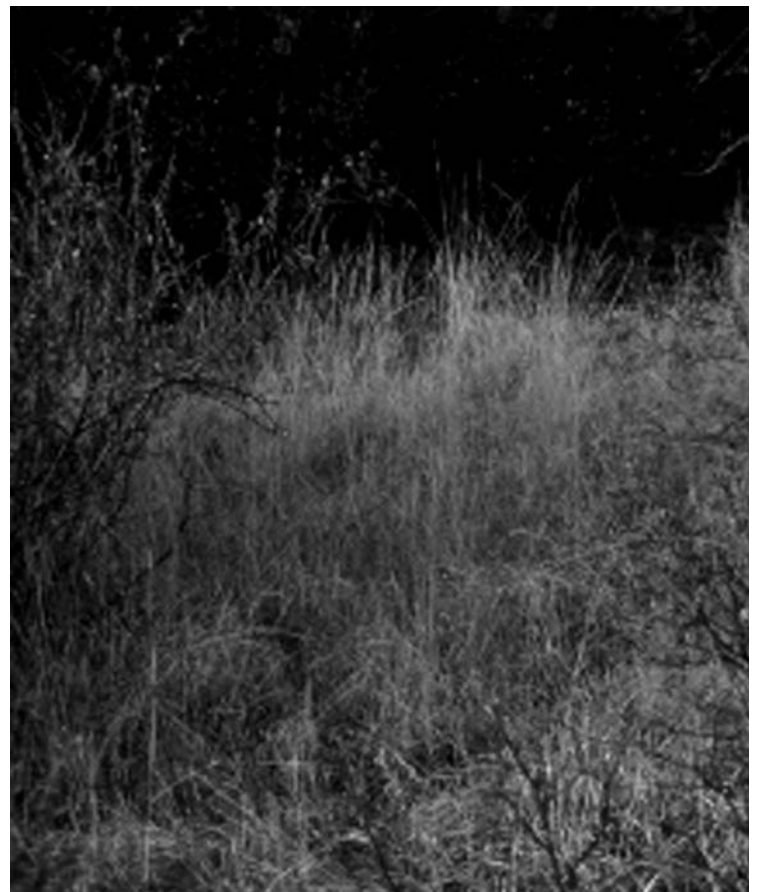
A natural turf of native grasses between Gambel oak and mountain mahogany shrubs only a few yards from the above photo. In its natural, undisturbed state, ground-covering vegetation in the Park should look like this.

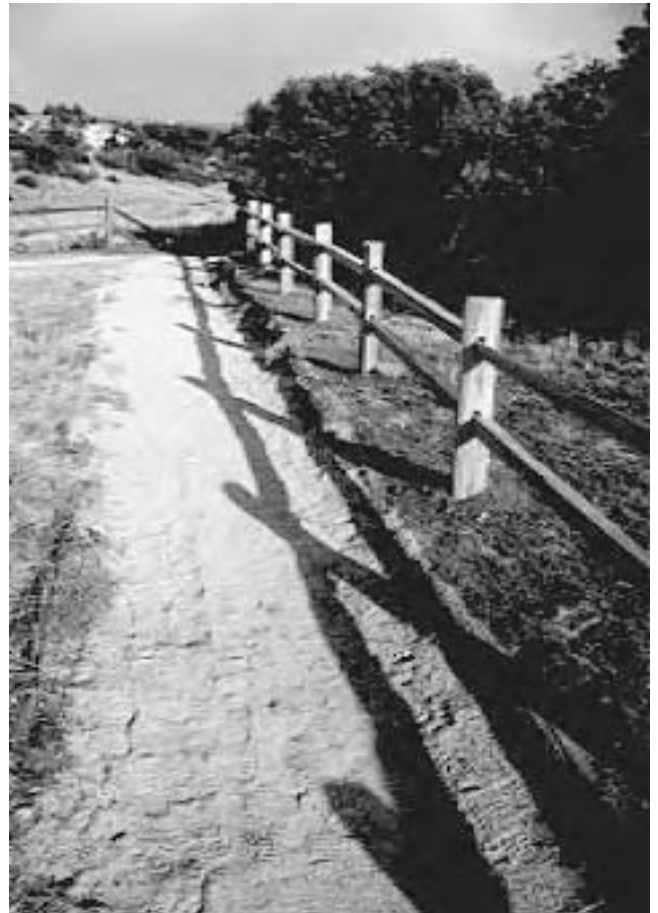
Class 1 Trails: Good condition with little to no erosion.

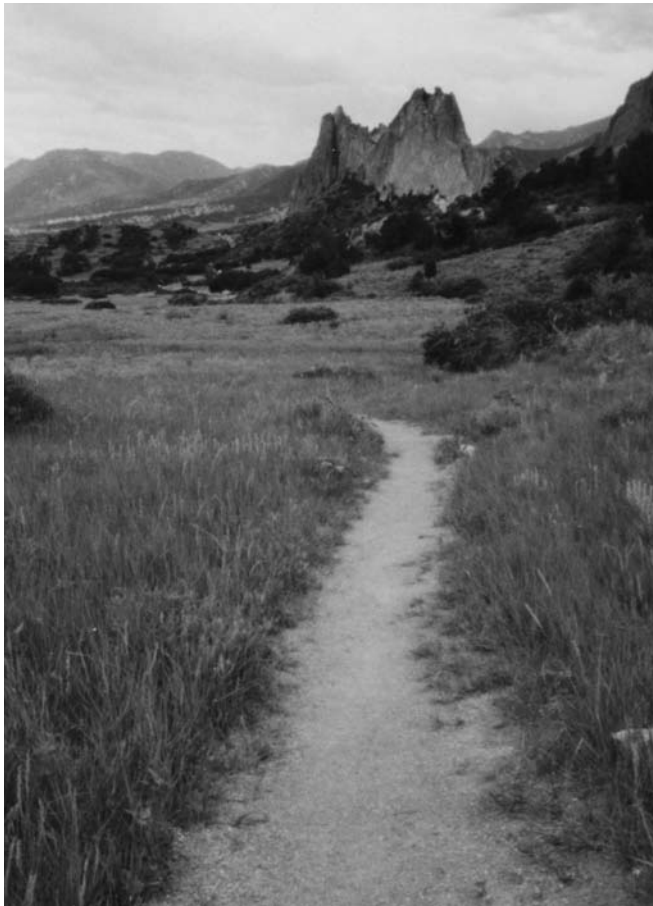
*Example of Class 2 Trails:
1-6 inches of soil loss.*

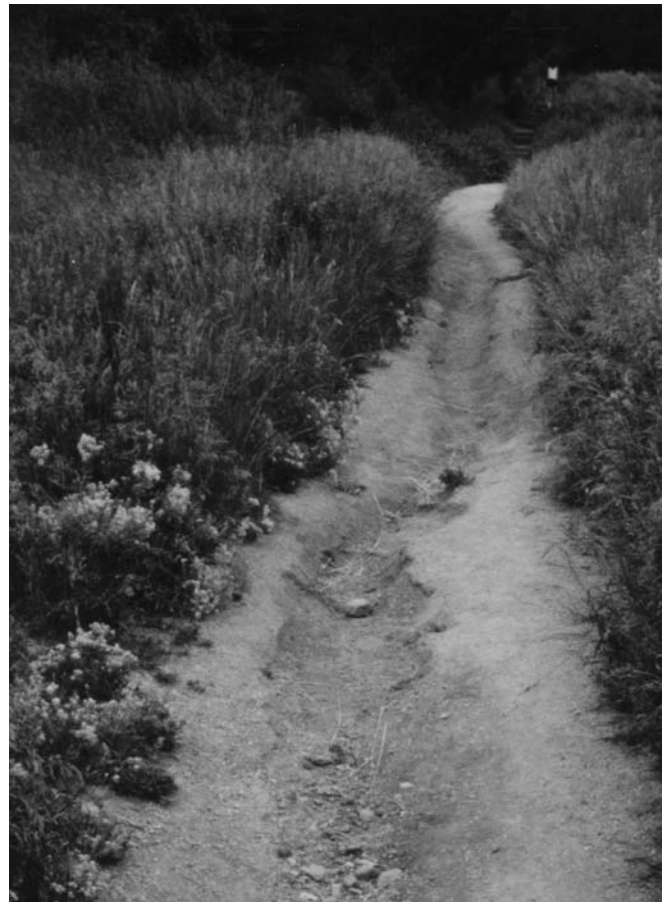
*Example of Class 3 Trails:
7-12 inches of soil loss.*

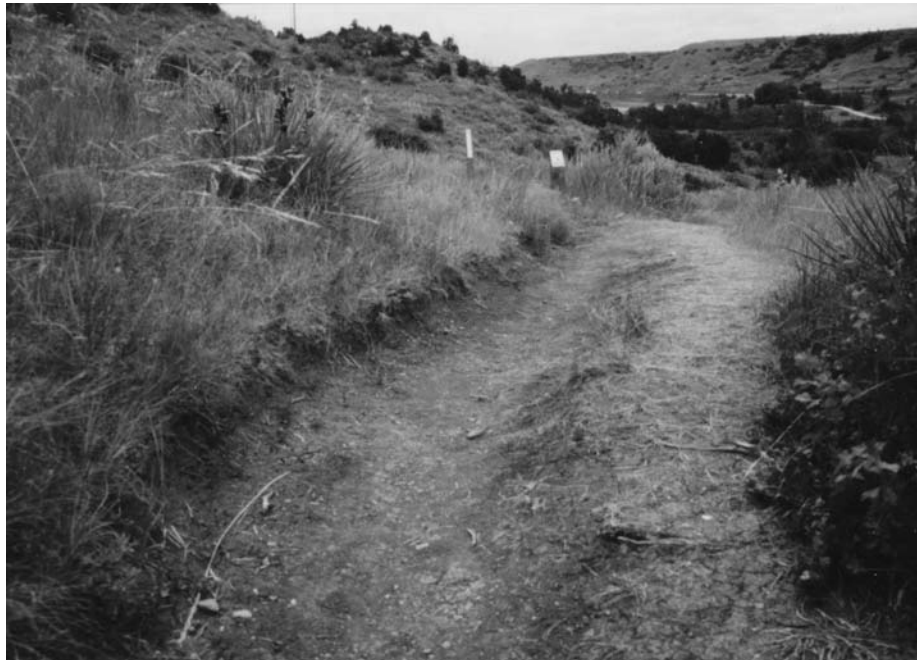
*Example of Class 4 Trails:
More than 12 inches of soil loss.*

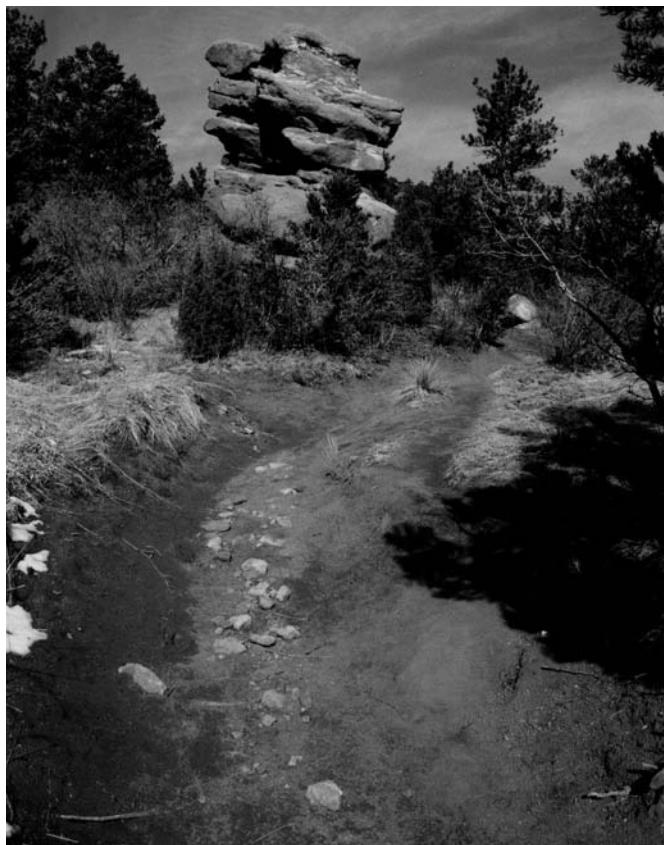
Many sections of the Park's designated trail system are severely degraded (Class 4), as this photo of the Palmer Trail shows.

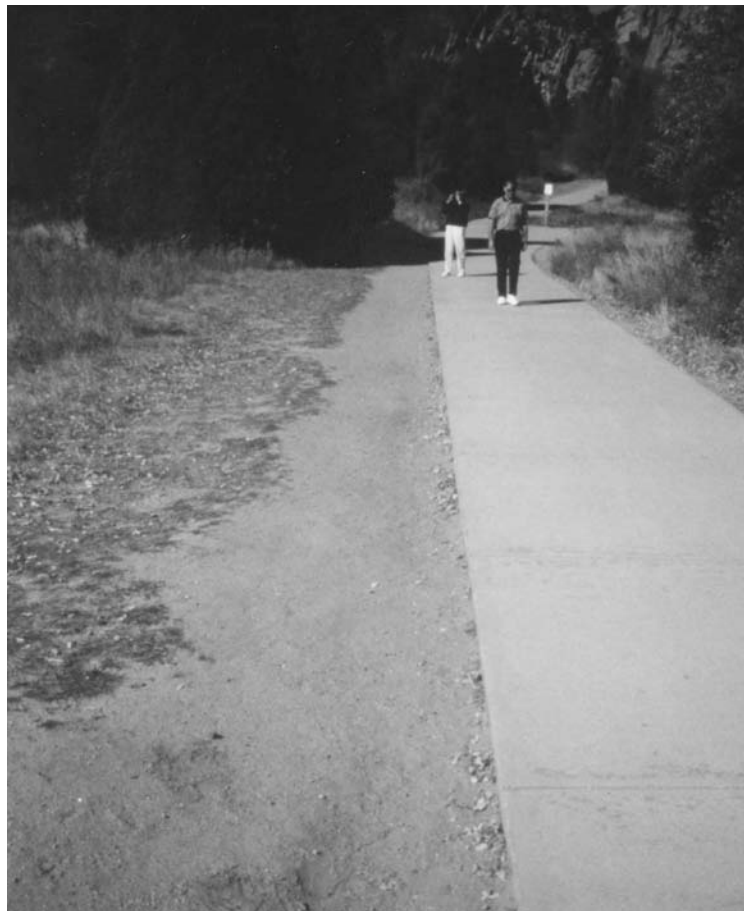
*Erosion (Class 3)
along the edge of
paved (concrete)
walkway in central
Garden zone.*

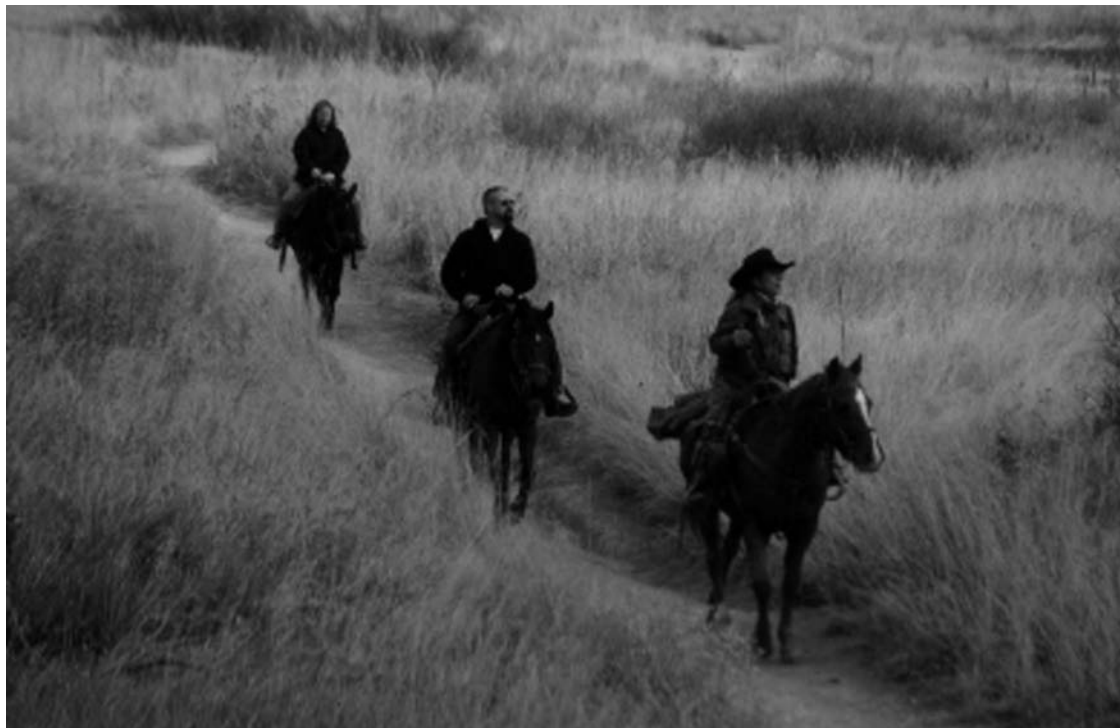
Commercial equestrian ride on the Bretag Trail. The commercial operator presently conducts between 16,000- 20,000 rides per year over roughly 5 miles of trails.

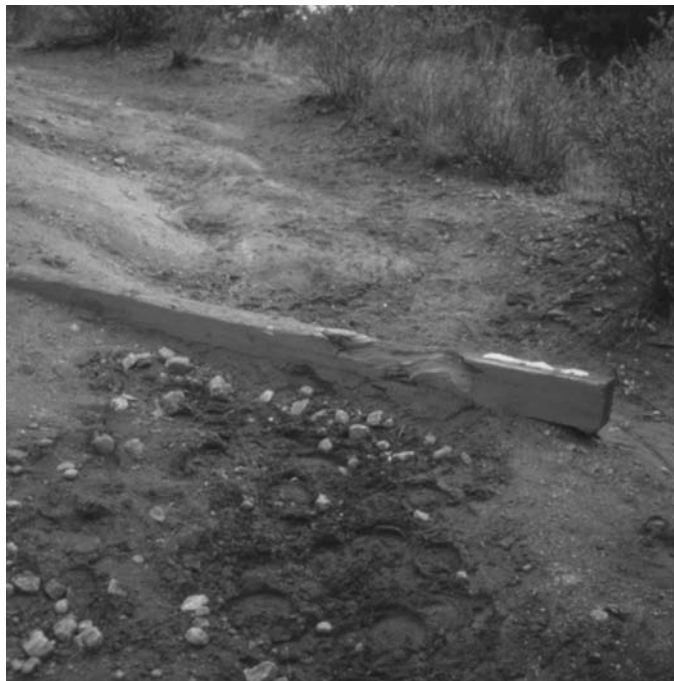
Trail erosion, more than 1 foot of soil loss (Class 4), on same section of Bretag Trail as photo on page 18.

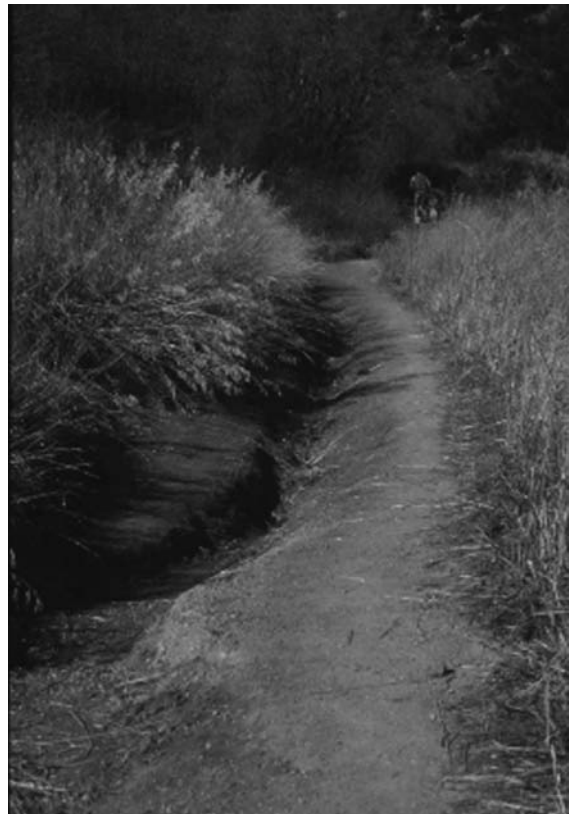
Damaged trail structure. Trails in the Park were never designed or built to accommodate high levels of equestrian use.

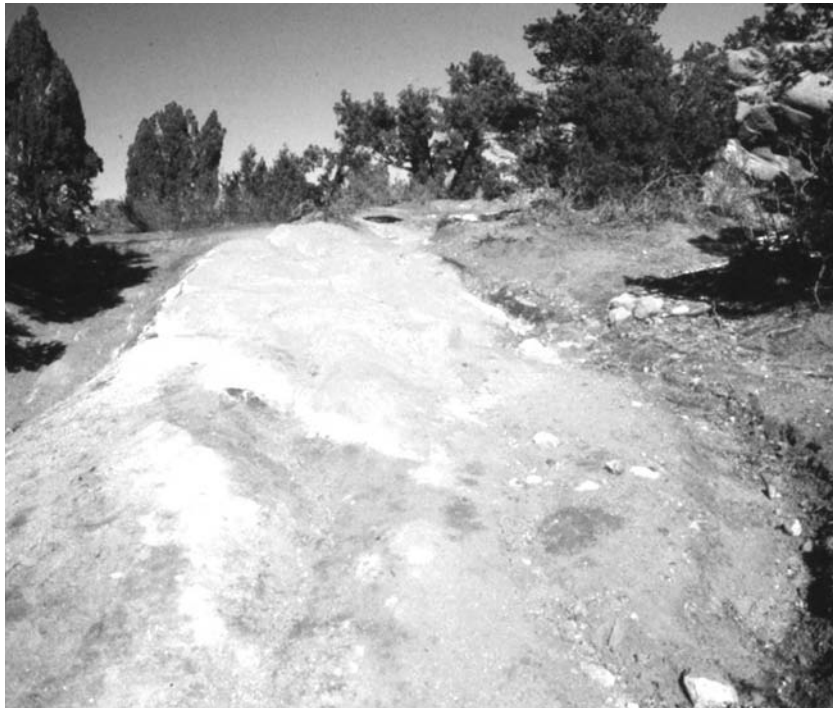
This photo shows a section of Scotsman Trail that is heavily used by commercial equestrian rides. The trail is severely eroded with several feet of soil loss.

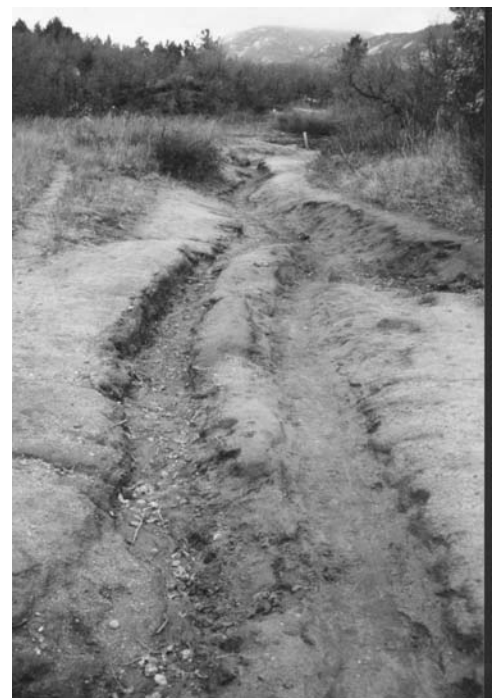
Trail erosion on same section of trail as above. Water runoff and drainage has resulted in higher than normal soil erosion.

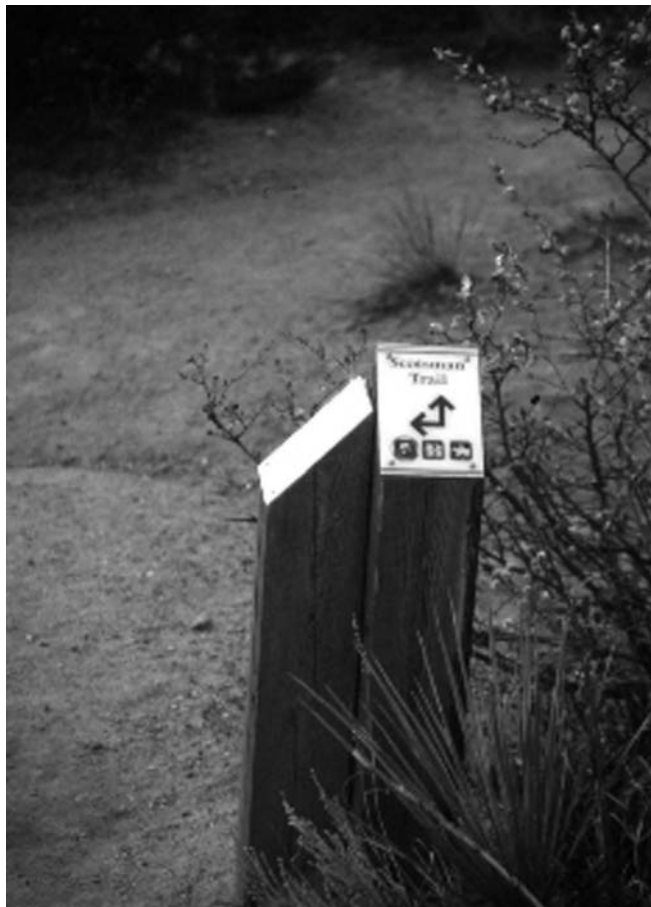
This photo shows a confusing sign at a trail junction on the upper Scotsman Trail. Arrow pointing up on the junction sign points to a well-developed social trail, indistinguishable from the eroded Scotsman Trail with which it connects. The designated trail actually makes a "hairpin" bend here, with both forks going to the left, not a right angle as shown on the sign.

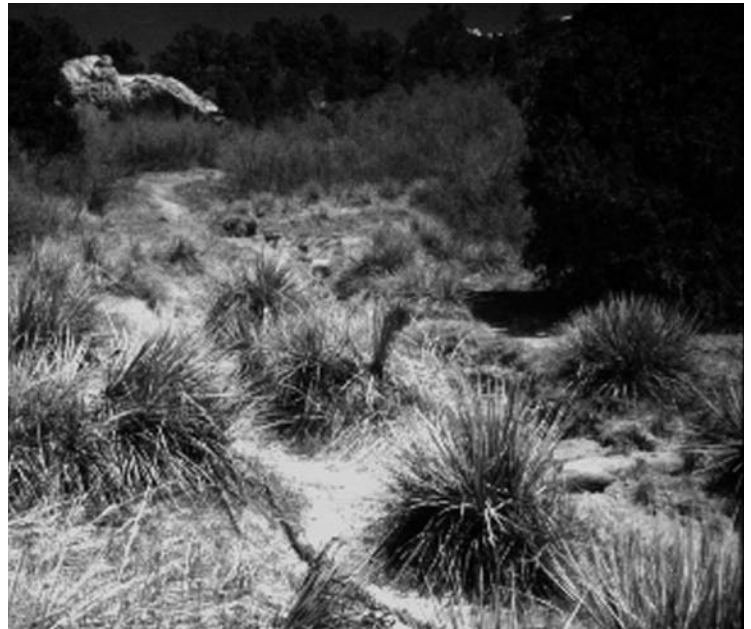
“Spider web” effect of social trails. In many cases plants communities become fragmented and only “pedestals” of plants remain. Eventually these plants will be lost, resulting in further erosion.

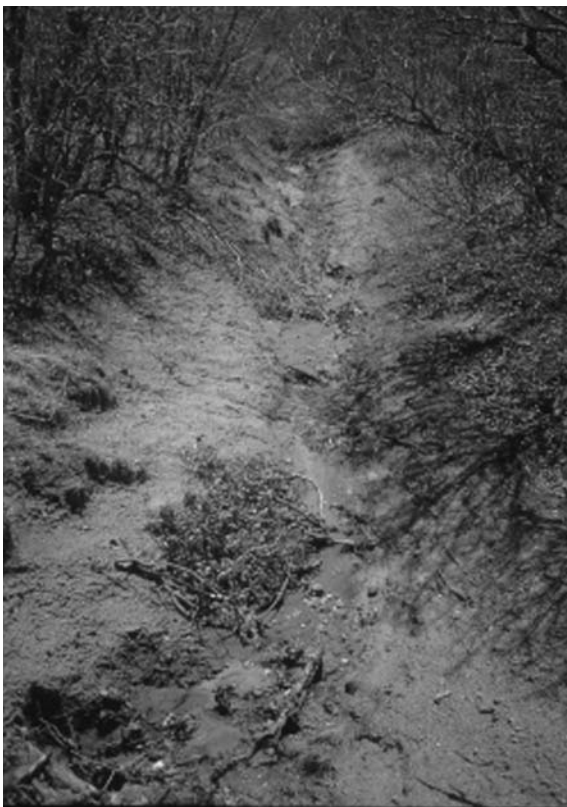
Social trail to the west of the Scotsman Trail. Though seldom used, it remains a significant erosion gully.

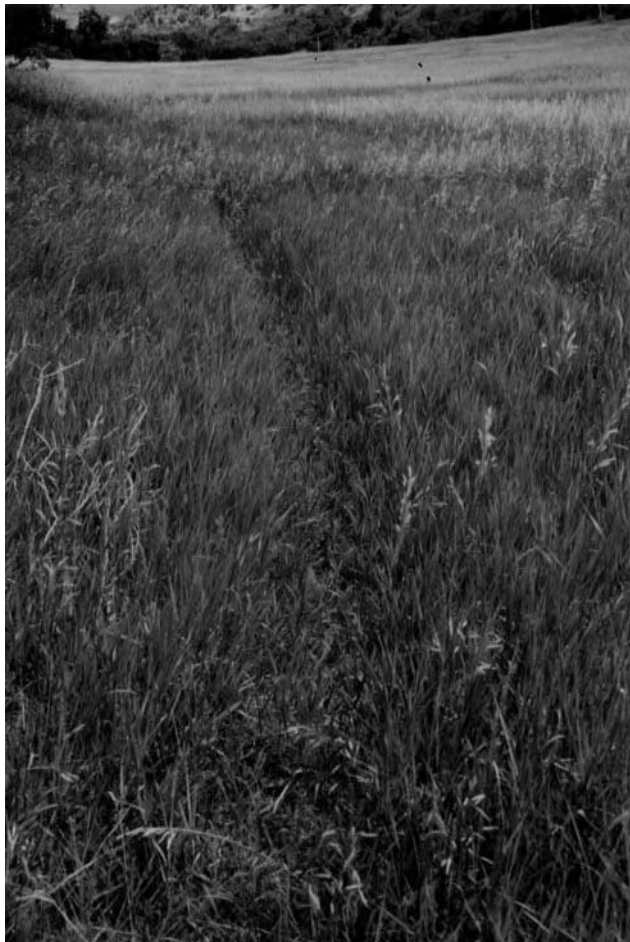
*Class 1 Social Trail:
Vegetation trampled but mostly present;
minor soil loss.*

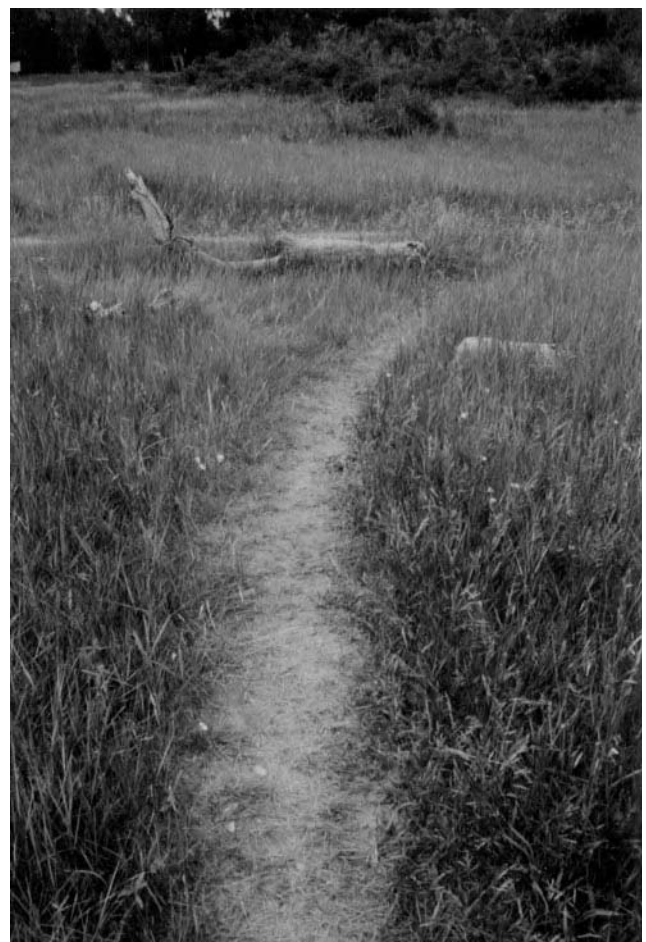
*Class 2 Social Trail:
Up to two-thirds of vegetation gone; soil
loss from 1-2 inches in some places.*

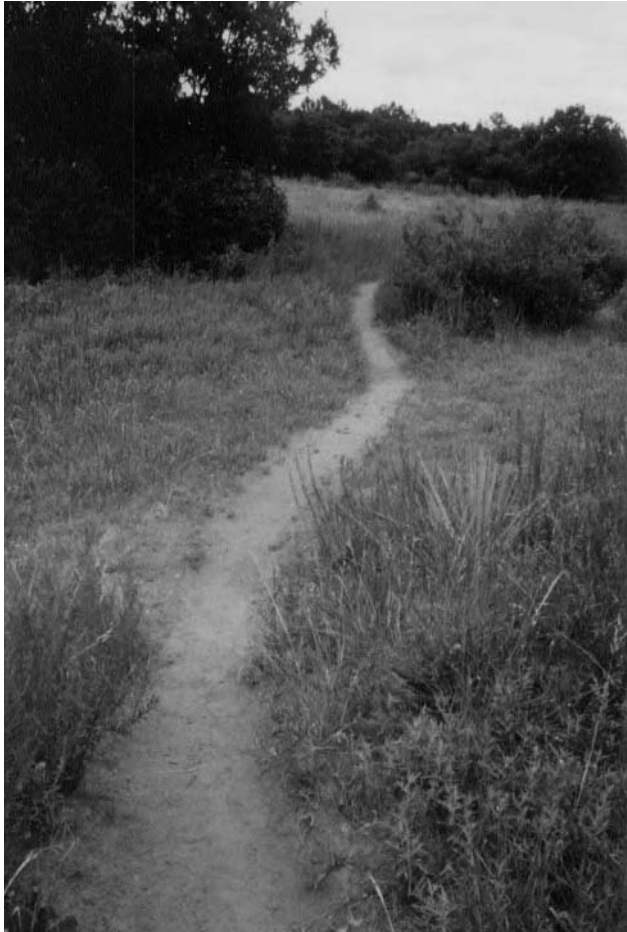
*Class 3 Social Trail:
Vegetation mostly gone; width less than 24
inches; 1-6 inches of soil loss in most places.*

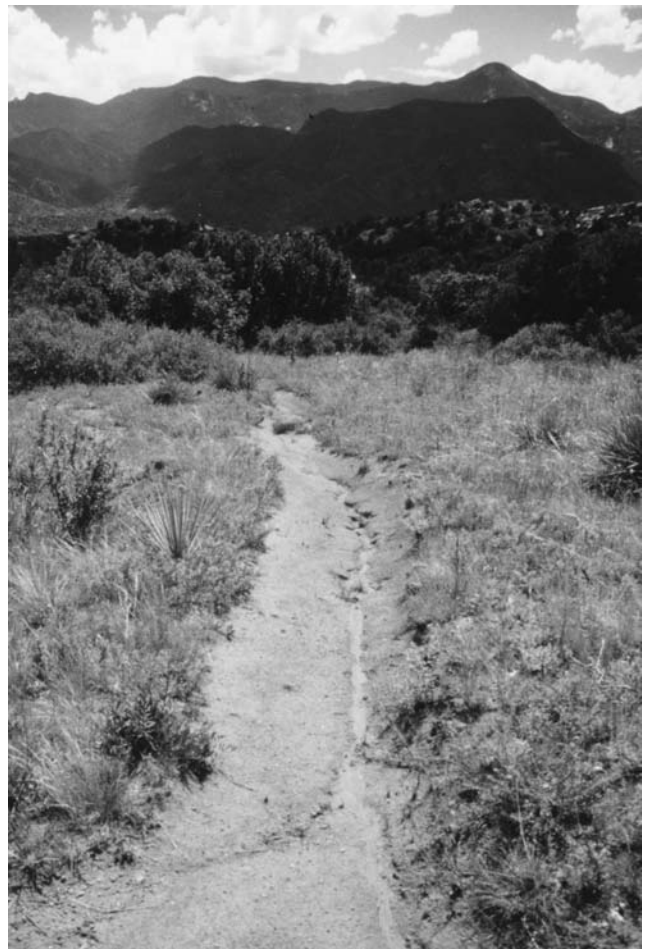
*Class 4 Social Trail:
No vegetation; width 24-42 inches; 7-12
inches of soil loss in most places.*

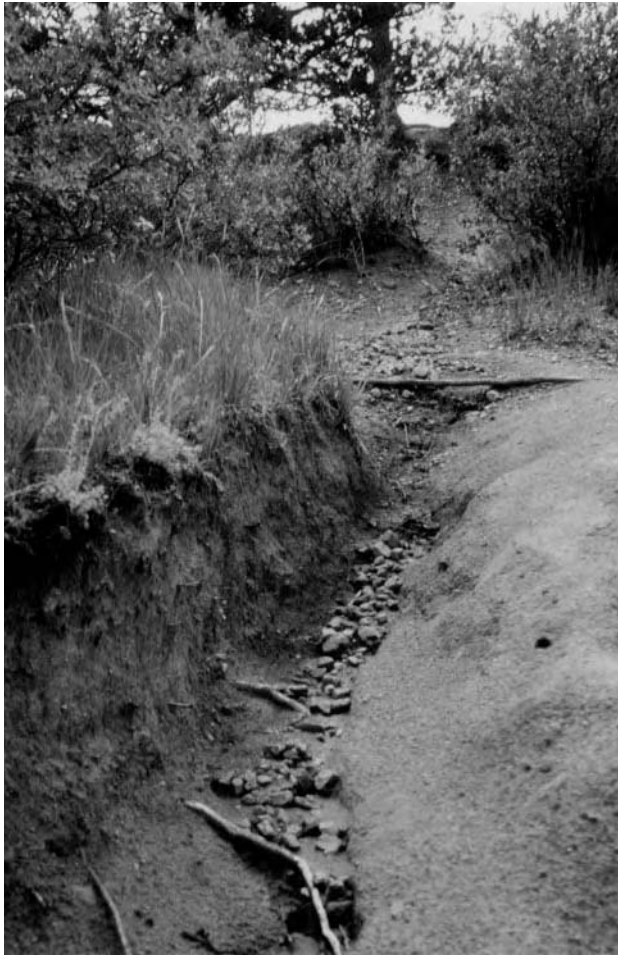
*Class 5 Social Trail:
No vegetation; width greater than 42
inches; more than 12 of soil loss.*

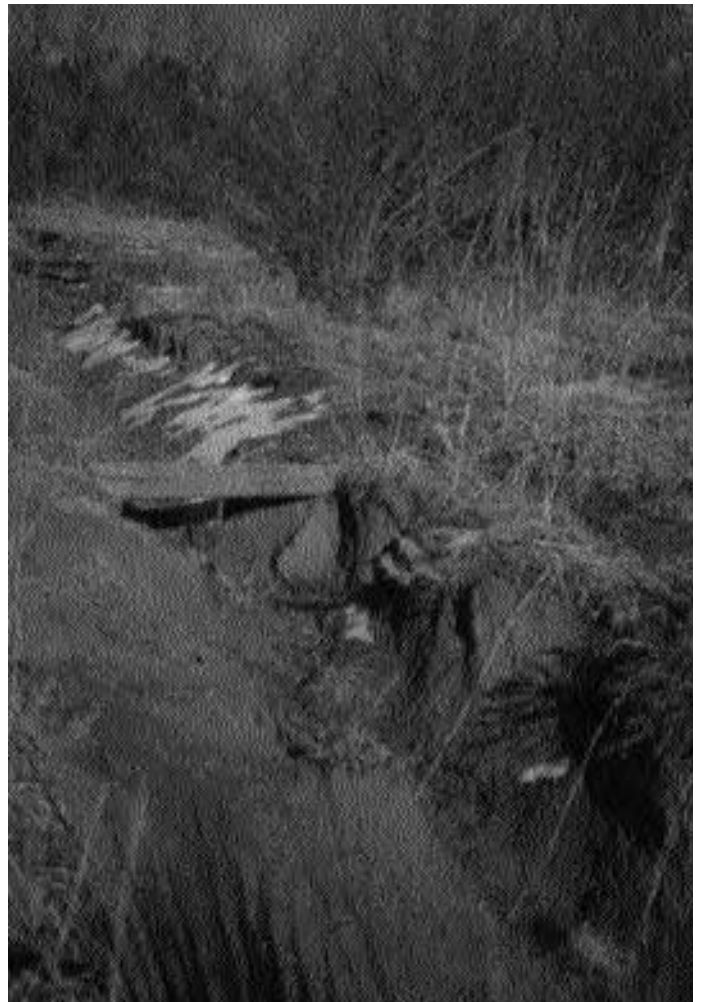
Note: Abandoned trail west of Scotsman Trail.

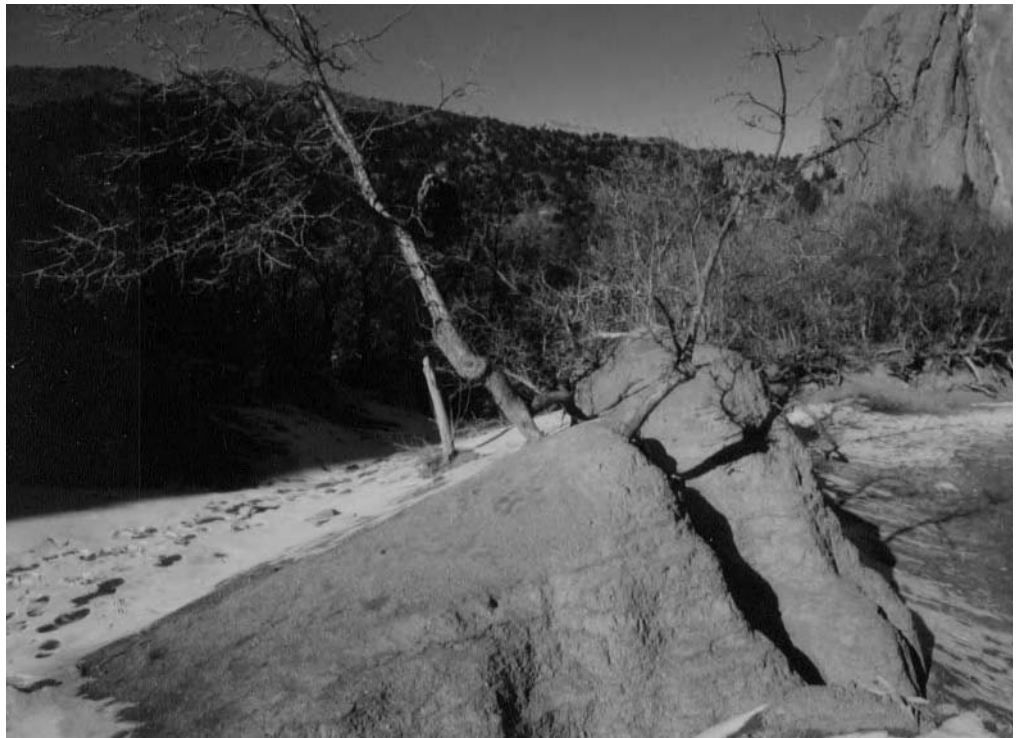
. . . to areas that have become severely eroded, like this site on the west side of the Three Graces formation.

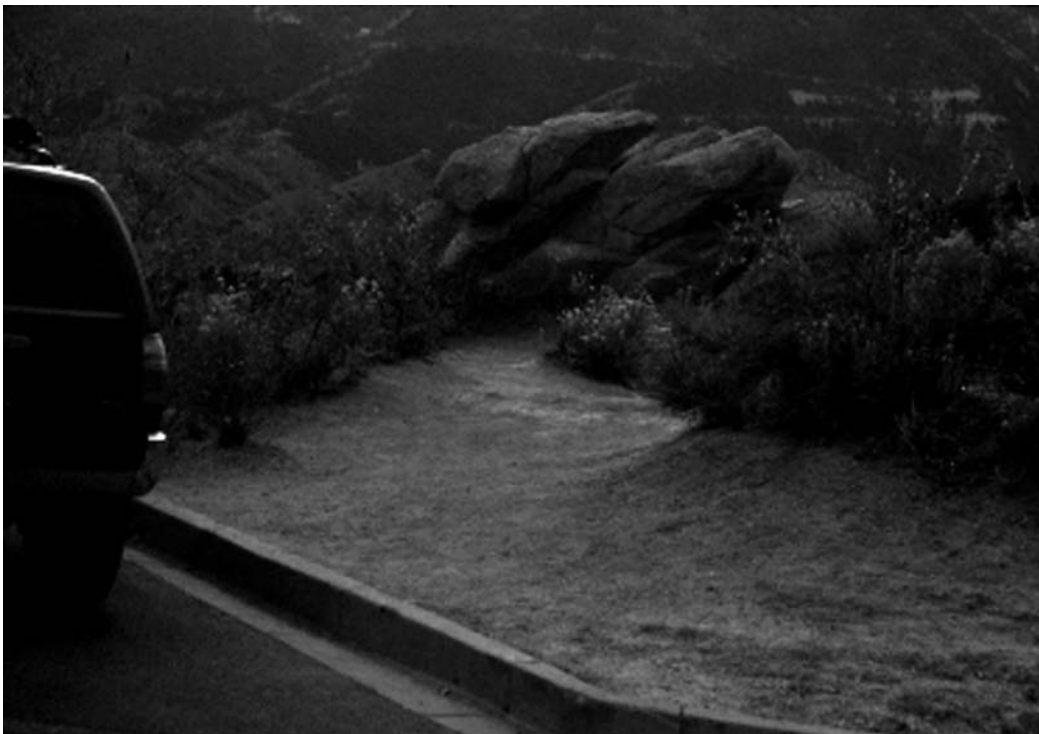
Viewpoint near the junction of Juniper Way Loop and Garden Drive. Soil erosion and vegetation loss at this site is typical of pullouts and parking sites along roadways throughout the Park. Social trails emanate from these sites toward other locations within the Park.

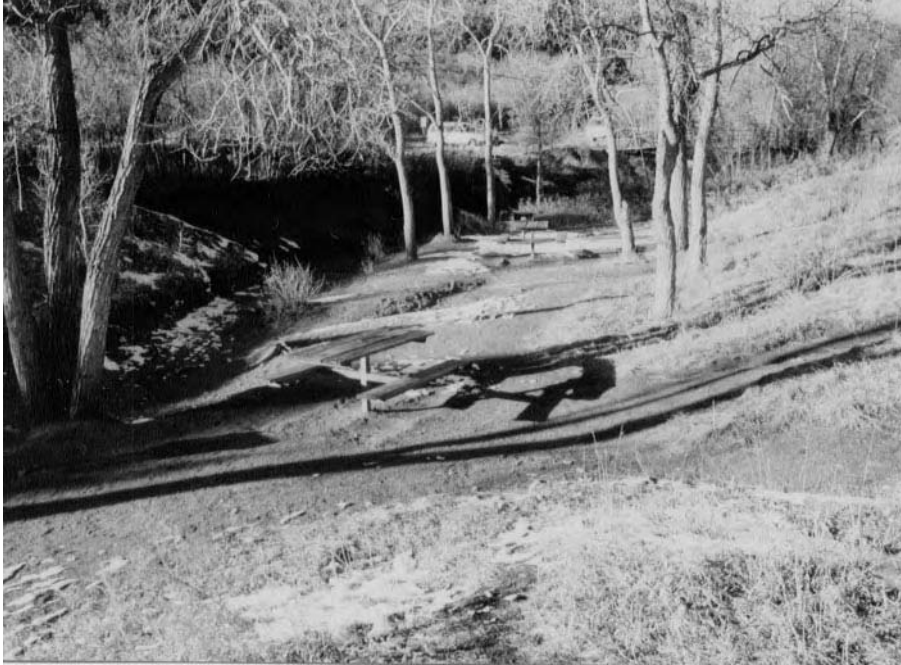
Scotsman Picnic Area. Vegetation loss and soil erosion has occurred extensively in and around this site. The drainage and slopes below the parking area have also been compromised, contributing to increased soil erosion.

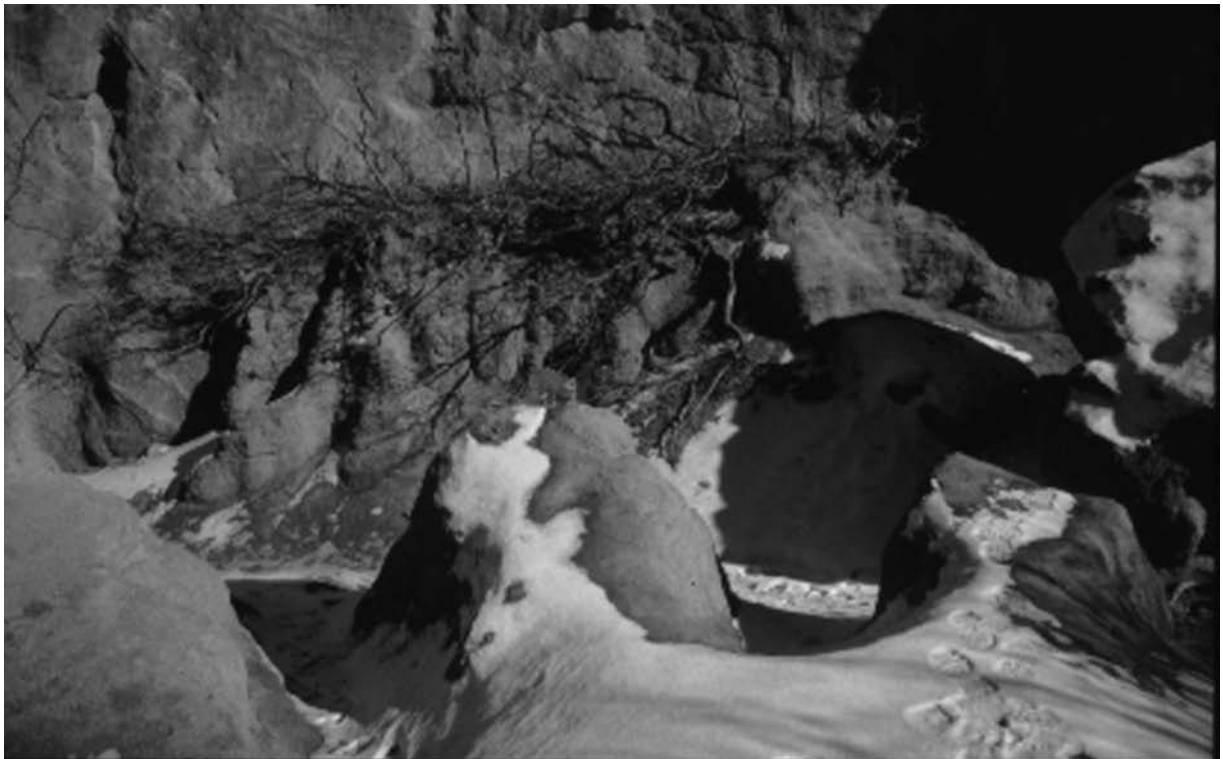
Three Graces formation, a major landmark in the central Garden zone. This site is one of the more heavily damaged sites in the Park. Hundreds of cubic yards of soil has been lost here. The original surface level of the terrain is indicated by the shrubs in the photo.

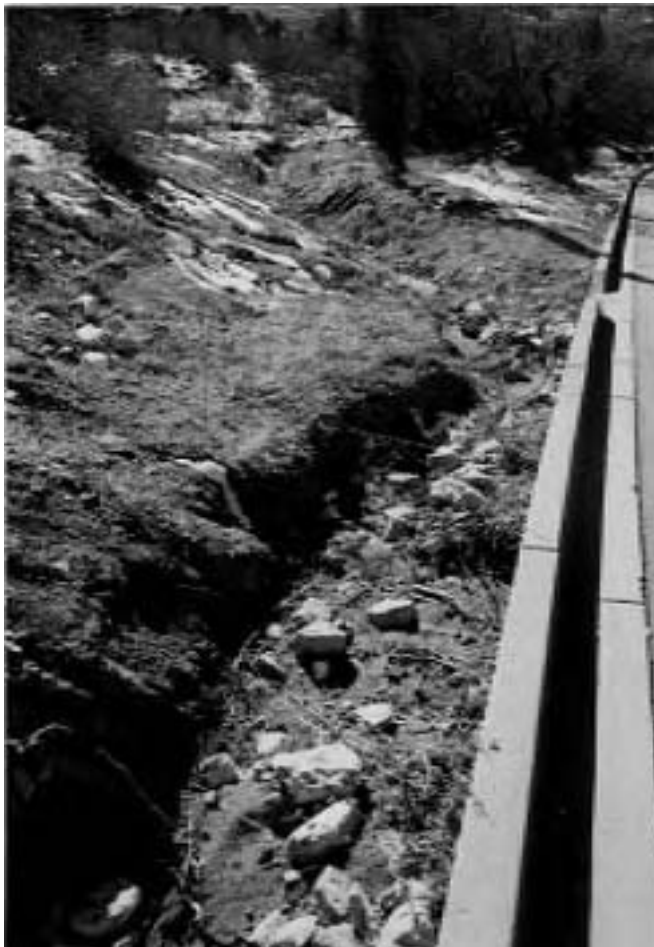
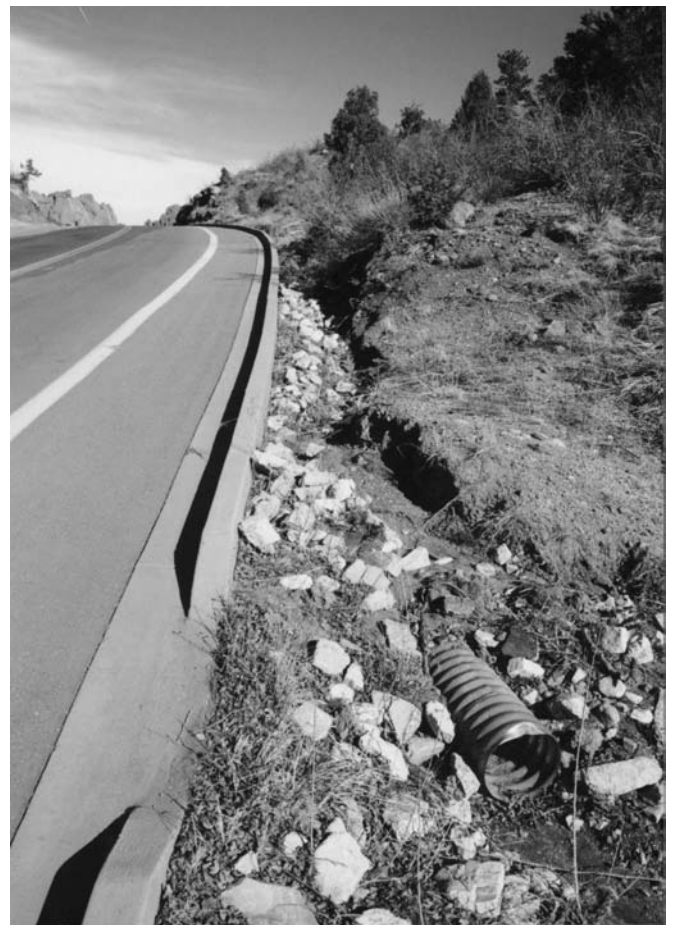
Examples of the erosion occurring along the edges of the roadways in the Park.

Significant erosion is also occurring along the perimeters of the roadways in the Park. Erosion control structures are needed to prevent erosion.

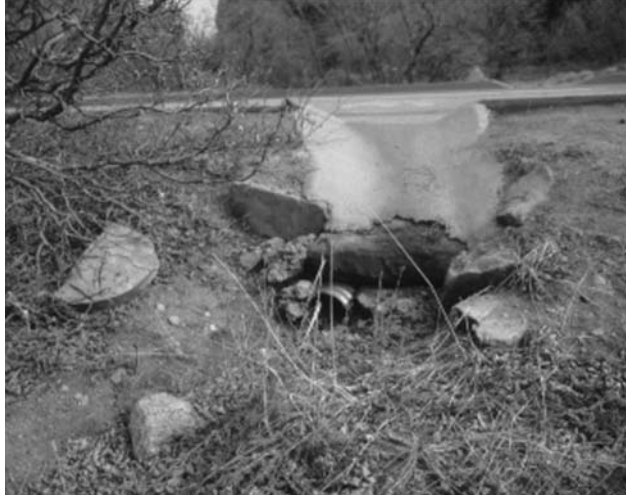
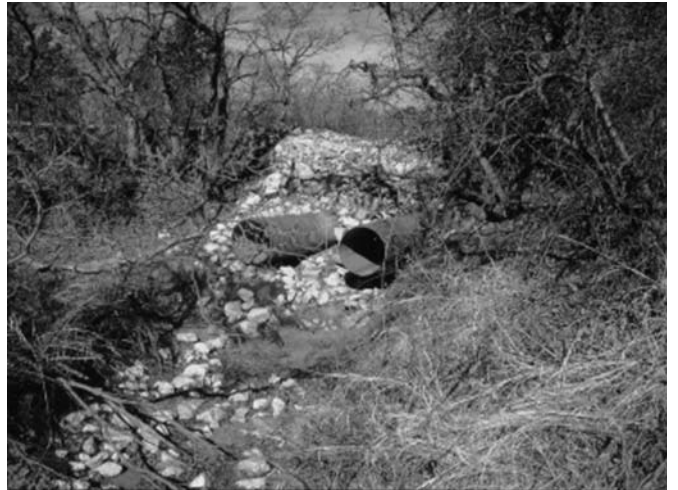
Curb cuts and drainage structures in the Park like the ones shown in the above photos are not adequately controlling runoff volume and velocity when major storms occur. This is accelerating natural erosion in the drainages into which the runoff is directed.

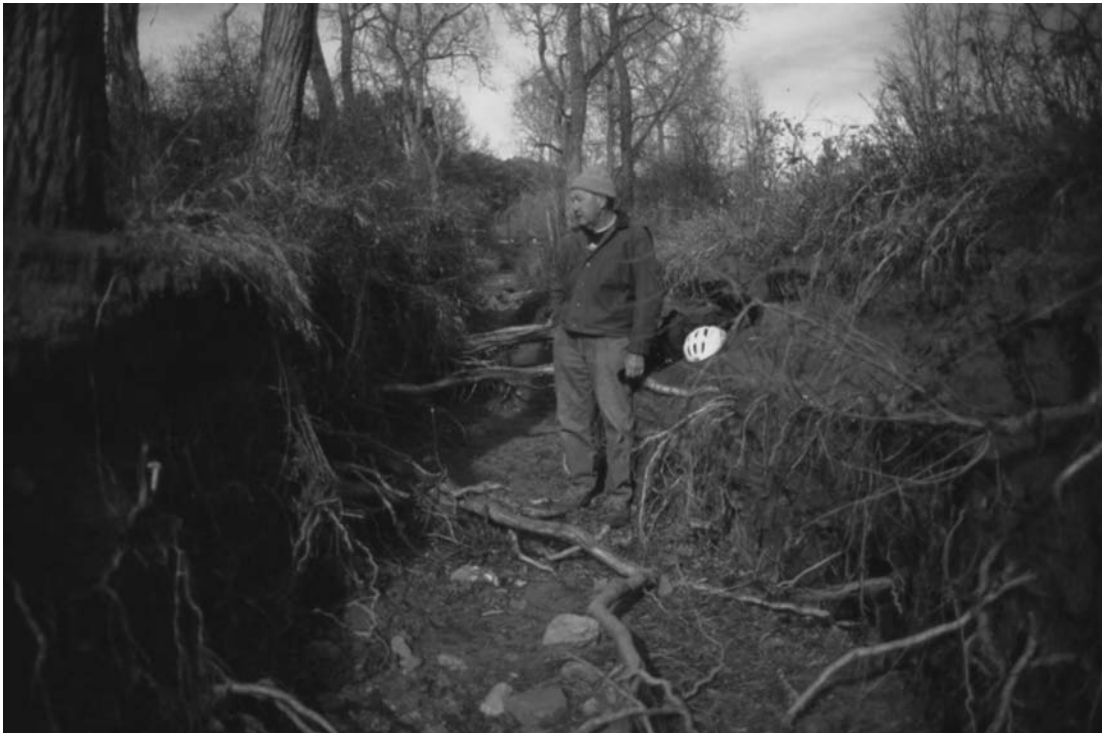
Erosion in the streambed near the Scotsman Picnic Area.

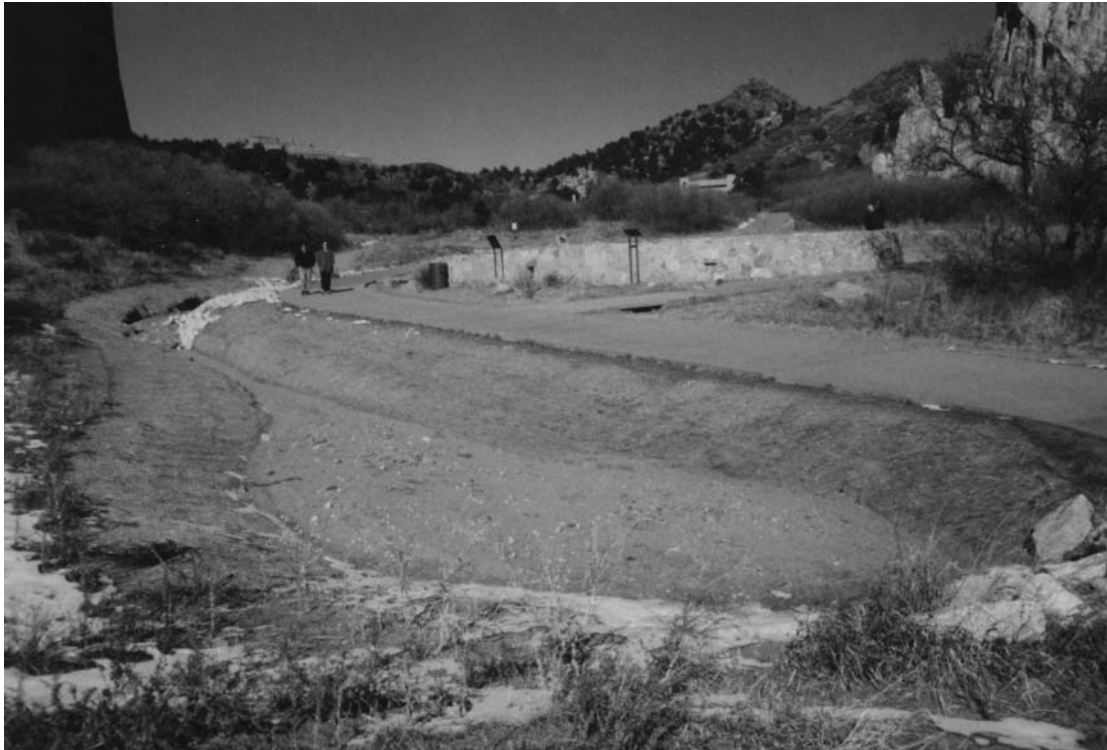
This photo shows the drainage gully on the east side of North Gateway (Kissing Camels Rock). A sewer line for the toilets near the parking lot was installed, but the site was not fully restored. A gully of this size never existed at this location.

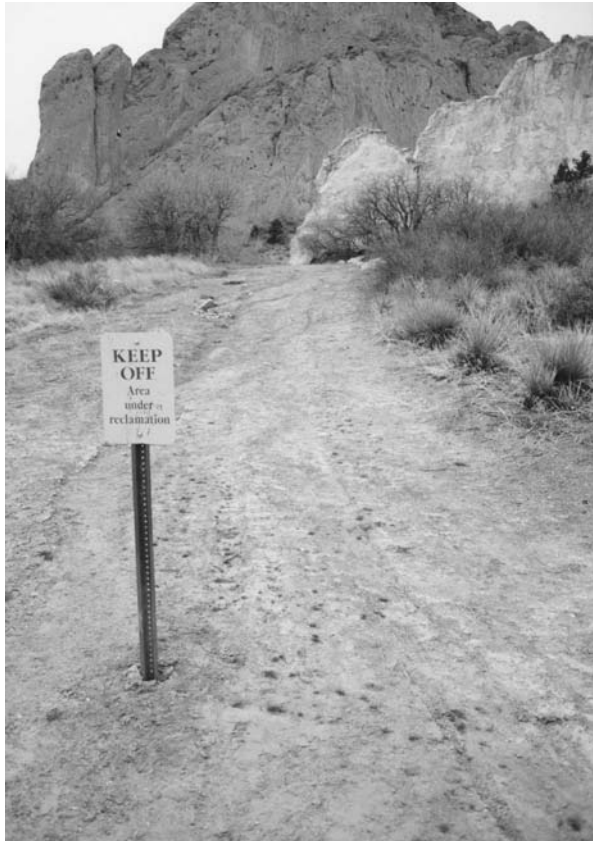
Palmer Trail re-route (old trail on right). Failure to restore the old trail has resulted in an increase in ground disturbance at this site.

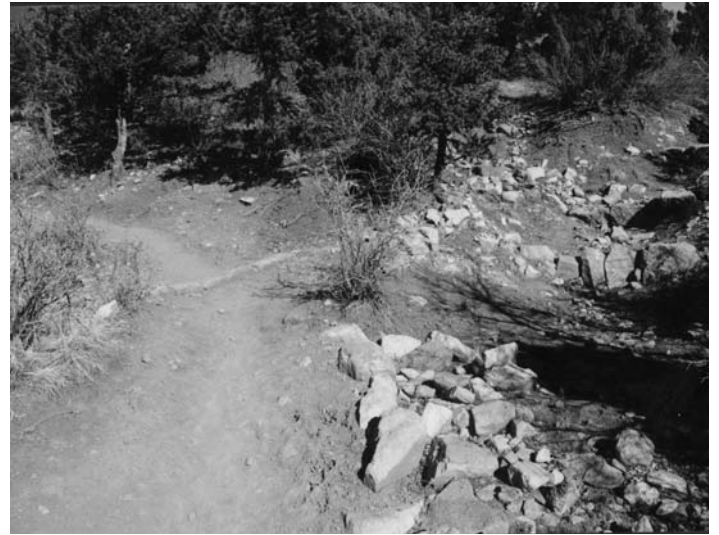
An, as yet, unsuccessful restoration of the new sewer line cut just east of North Gateway (Kissing Camels) Rock.
