Garden of the Gods Restoration Report

Current Conditions and Recommendations

Prepared for
Parks & Recreation Department
City of Colorado Springs, Colorado

Rocky Mountain Field Institute
Bruce Byers, Jim Ebersole, & Mark Hesse, Consultants

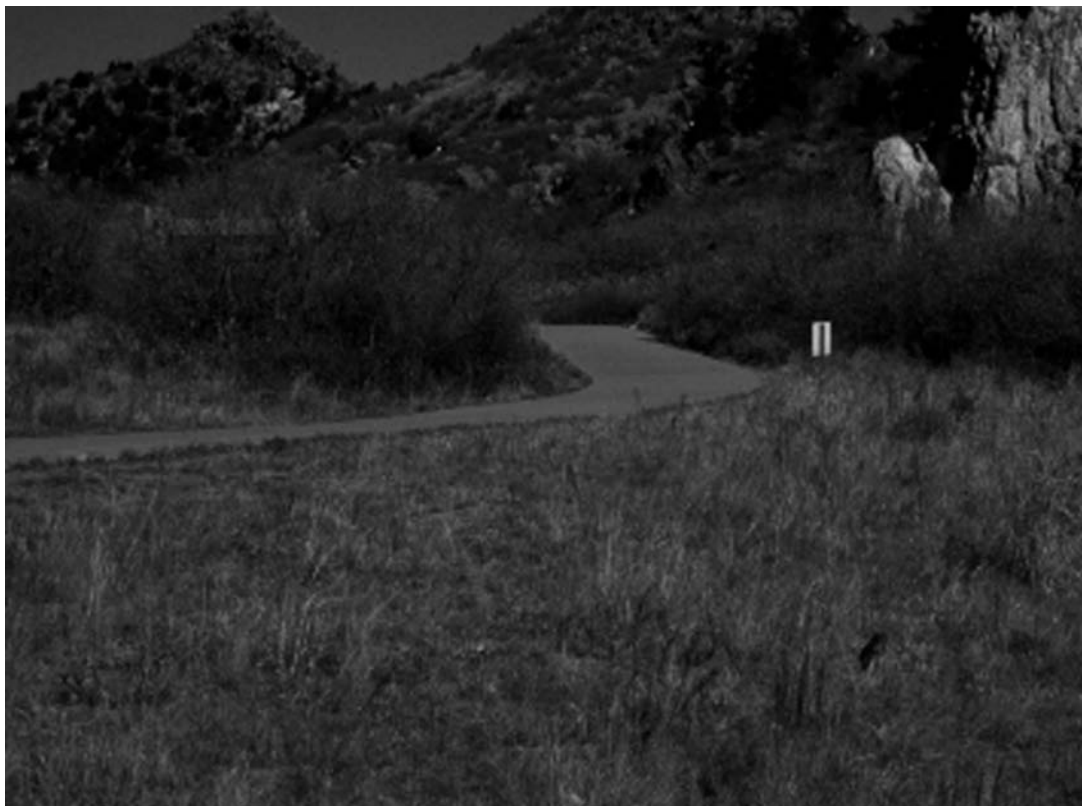
Successful revegetation of the area just south of the Main Parking lot with native grasses.

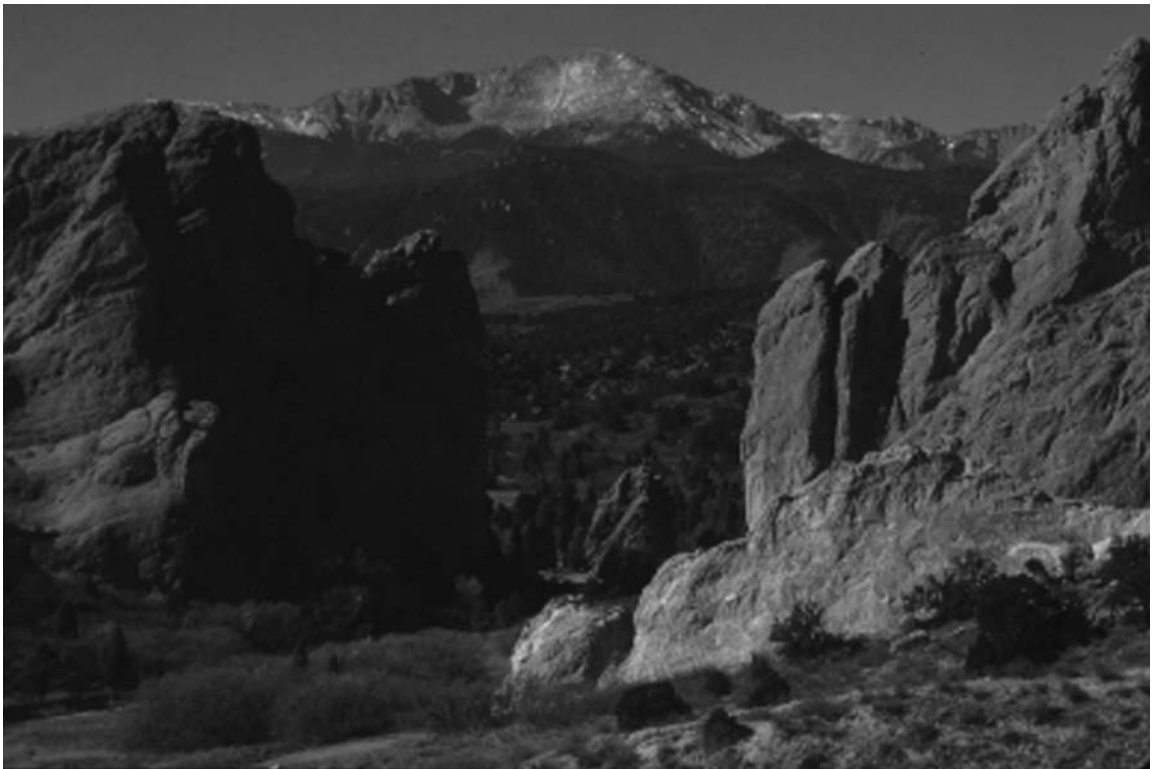
A 1999 photo from the same viewpoint as the Paris painting and the 1925 historic photo on the previous page. This photo, and the ones on the following page, show the change in vegetation cover and density over the past one hundred and twenty-five years.

During the 1930s tree species not normally found in the Central Garden zone (including Rocky Mountain juniper, ponderosa pine, and white fir) were planted by the Civilian Conservation Corps. Today, in many places these large, mature trees block the dramatic views from and to the Central Garden zone. These dense trees completely change the character of the landscape, from an open situation to an almost forested setting. The dense, highly flammable evergreens also increases the risk of fire in the urban-wildland interface. Cutting some of the planted trees that did not occur in the Central garden zone before the 1930s is recommended. Cutting should begin with those trees growing immediately along roads and trails that block views of the sandstone monoliths (this would be perhaps 5 to 10% of the total planted trees in that area). Thinning some planted trees away from roads and trails and selectively thinning the very tall scrub oak would also open up views and reduce fire danger.

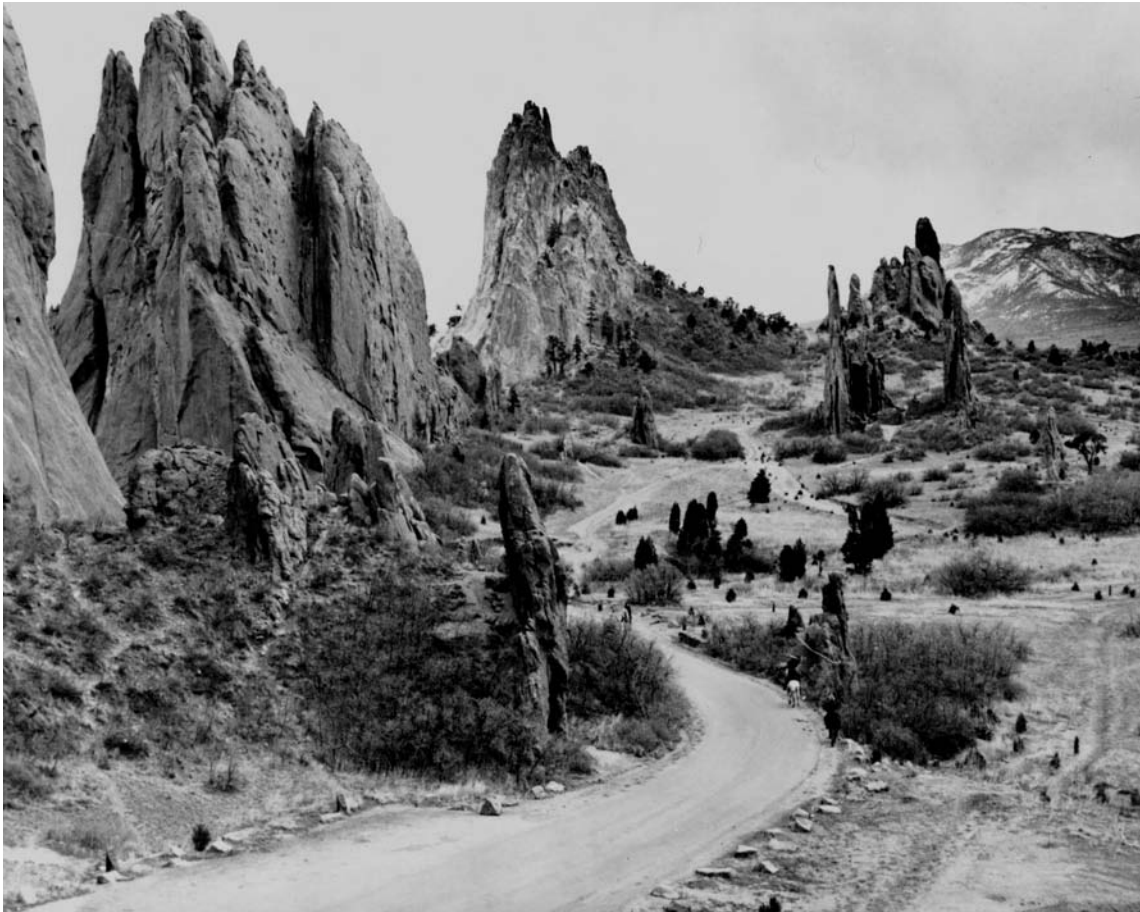
Undated photo of the central Garden zone, probably from the 1930s. (Garden of the Gods Collection, Pioneers Museum, Colorado Springs).

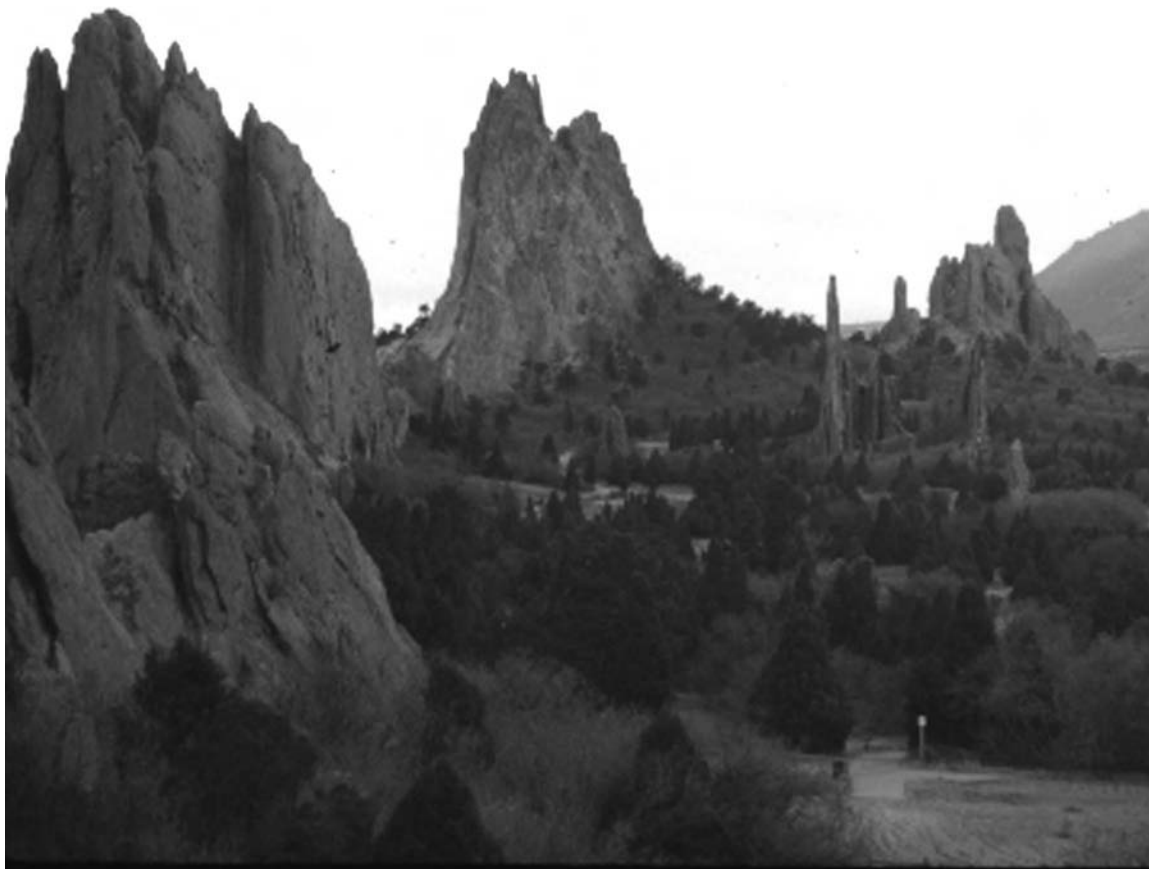
1999 photo of the central Garden zone. This photo compared to the photo above shows the dramatic change in vegetation that has occurred within the last 70 years.

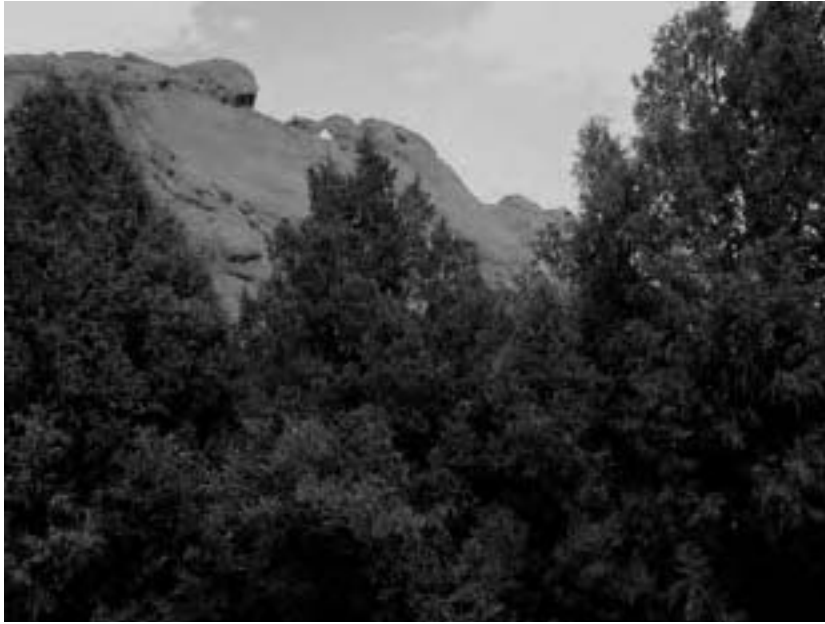
Rocky Mountain juniper (planted) and native scrub oaks grow tall along the edge of Juniper Way overlooking the Central Garden zone, blocking the scenic views of the Central Garden zone for visitors driving as well as walking through the Park.

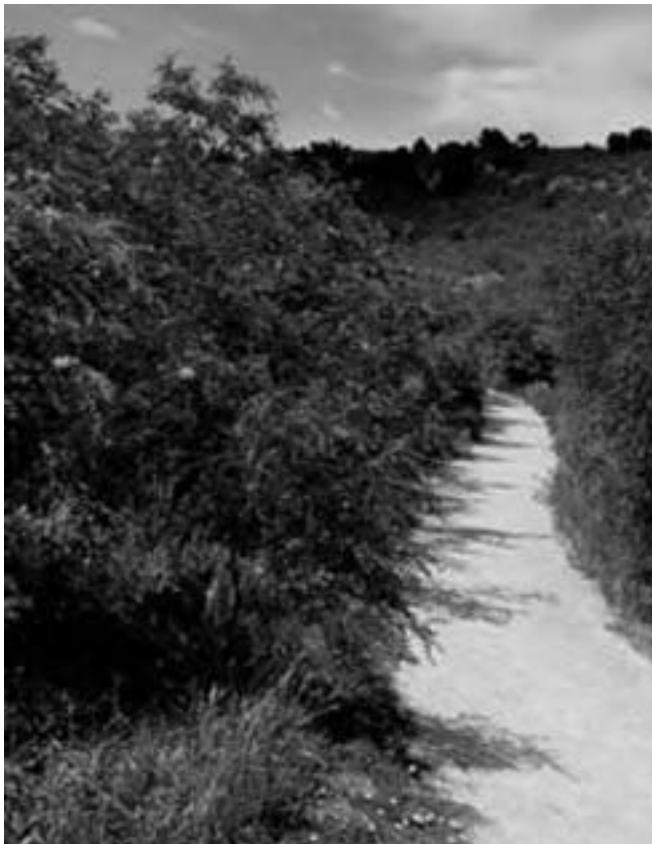
New Mexican locust, a non-native shrub growing along the Bretag Trail. Other “invader” plant species now grow throughout the Park.

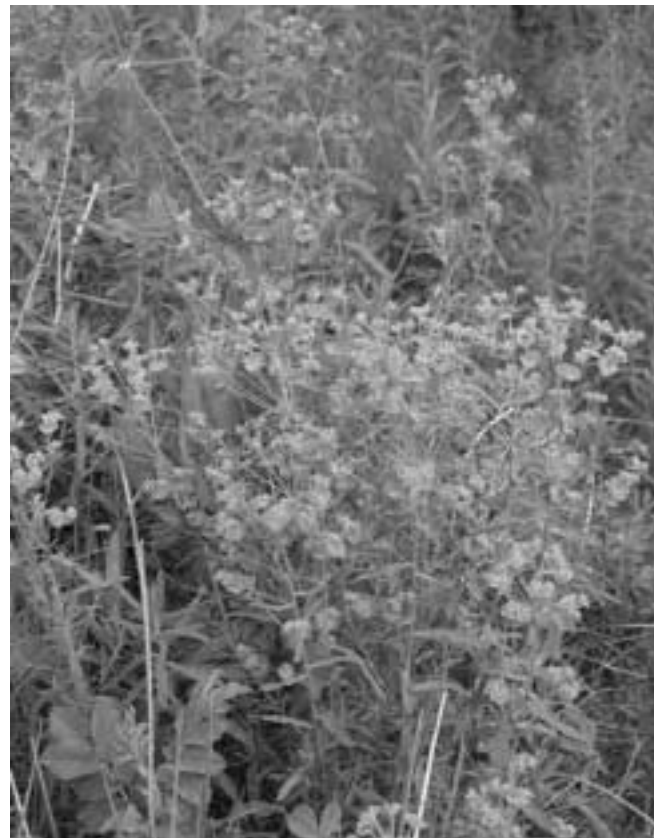
Leafy spurge, one of the several noxious weeds found in the Park.

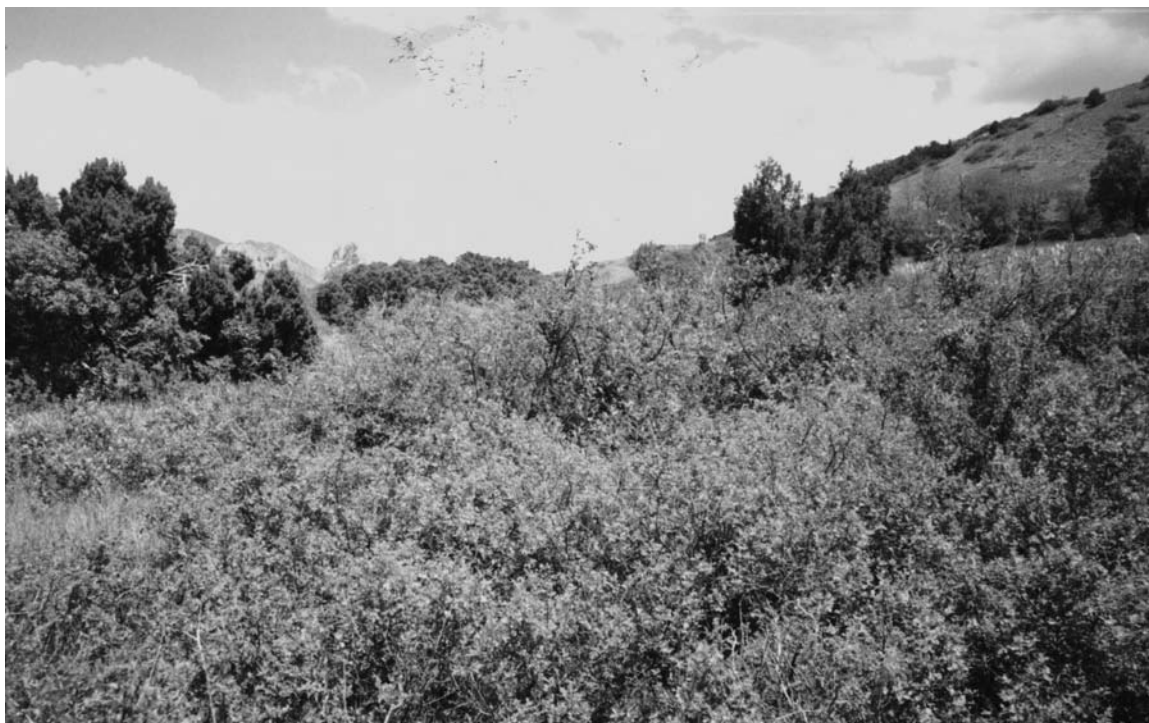
The dense shrubs east of Camp Creek provide potential habitat for the threatened the Preble's meadow jumping mouse.

The Garden of the Gods contains areas of potential habitat for Preble's meadow jumping mouse. (See Restoration Report Wildlife Habitat map). Preble's meadow jumping mouse, *Zapus hudsonius preblei*, is a rare subspecies of meadow jumping mouse whose distribution is limited to portions of Colorado and Wyoming. In 1998 it was listed as threatened by the U.S. Fish and Wildlife Service. Locations slightly north of the Garden of the Gods represent the southernmost known populations of the species. The preferred habitat of this species consists of drainages with well-developed vegetation characterized by diverse grasses, forbs, and shrubs, especially willows. The 1.5 mile section of Camp Creek in the Garden of the Gods Park north of Rock Ledge Ranch provides exactly the type of habitat needed by this species. This area would be able to support a population of 75 to 100 mice. If present, this would be a disjunct and isolated population of Preble's mouse, because suitable habitat no longer exists between this part of Camp Creek and sites to the north that support known populations of this species. No trapping studies were conducted as a part of this planning process to determine whether or not this species is currently present in the Garden of the Gods.
